# Navajo Abandoned Uranium Mine

# Site Screen Report

Mine Name: Yazzie No. 312

August 2011

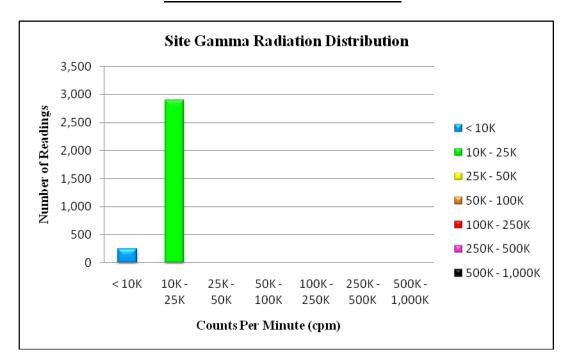
**Highest gamma radiation measurement:** 24,415 counts per minute (cpm)

**Background Average:** 14,187 cpm **Two Times Background:** 28,374 cpm

A total of 3,143 gamma radiation measurements were collected from the mine site, ranging from 7,600 cpm to 24,415 cpm. The measurements are represented in Figures 1 and 2.
